Lake Constance Water Supply: Water Analysis

Franziska Orth, Tim-Dominik Gómez

Dillmann Natural Science Team, Dillmann-Gymnasium, Germany
giuseppino@dillmann-gymnasium.de

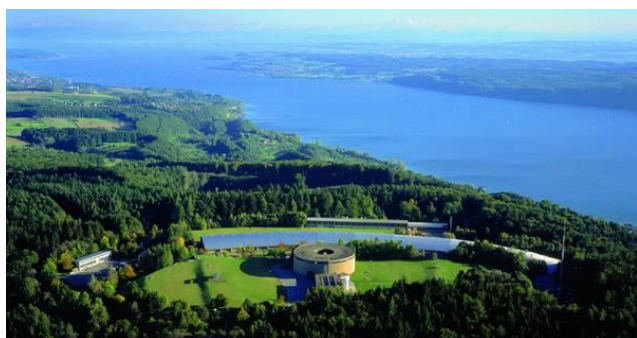
Figure 10: Aerial view of the water treatment plant in Sipplingen on top of a mountain (Sipplinger Berg). Lake Constance with the water intake is on the right side.
