**A Case Study Investigation into the Effectiveness of Waterbody Management:
Lorong Halus Wetland**

Raffles Institution

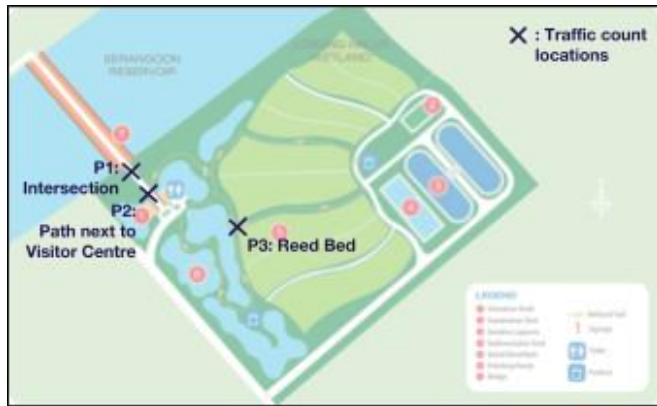
Figure 2: Locations of Traffic Count

Traffic counts of visitors were carried out from 8am to 6pm on Tuesday, 16 January 2018 and Sunday, 28 January 2018. The two dates were chosen so as to provide a means of comparison between a weekday and a weekend, allowing for better representation of human traffic and activities at Lorong Halus Wetland. Three points in figure 2 – namely (1) the intersection between Main bridge and the cycling path, (2) the path next to the visitor centre as well as (3) the interior of the wetland– were identified as they could adequately reflect the purpose of each visitor.

Moving from P1 to P3, there is an evident decreasing trend in the number of visitors observed, from 287 at P1, 187 at P2 to 7 at P3. There were 100 more visitors counted at P1 than P2, indicating that 20.8% of visitors merely crossed the bridge to Lorong Halus before turning back or onto the paths shown in figure 3. As such, a significant proportion of visitors were merely passing by Lorong Halus Wetland on the way to other locations and displayed a lack of interest in the waterbody itself. Similarly, a meagre total of 7 visitors passed by point 3 throughout the entire day, demonstrating how most of the visitors did not venture into the reed beds of Lorong Halus Wetland, which form the majority of its land area. The trends reflected thus indicate a severe under-utilisation of much of Lorong Halus Wetland and could also pose ramifications on the level of appreciation by visitors of the waterbody's main purpose and the effectiveness of the water education features situated there.

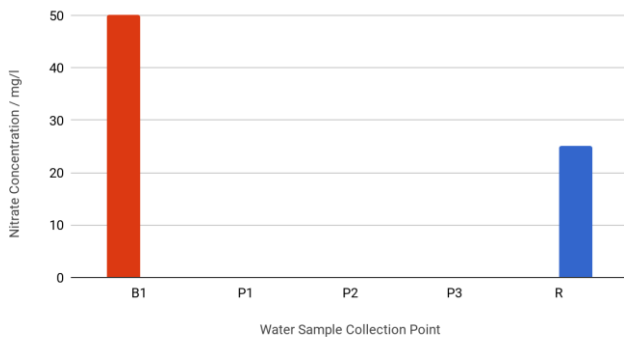
Figure 5: Graph of Nitrate Concentration 12 March 2017

Nitrate levels at the polishing ponds, shown in figure 5, were significantly lower than that of the reed beds, as evidenced by the reduction in concentration from 50 mg/l to 0 mg/l. A 25 mg/l nitrate concentration at the reservoir indicates that there is no significant leaching of nitrates into it.

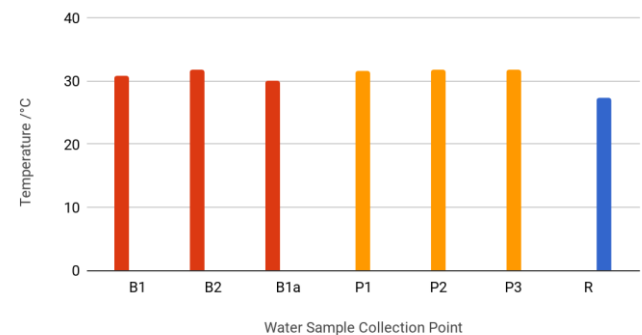
Figure 7: Graph of Temperature 2018

A dissolved oxygen concentration of 4 ppm was observed at all water sampling locations. The temperatures of the water samples collected were largely similar, with an average of 31 °C. The temperature of the reservoir water sample was slightly lower in comparison at 27.5 °C.

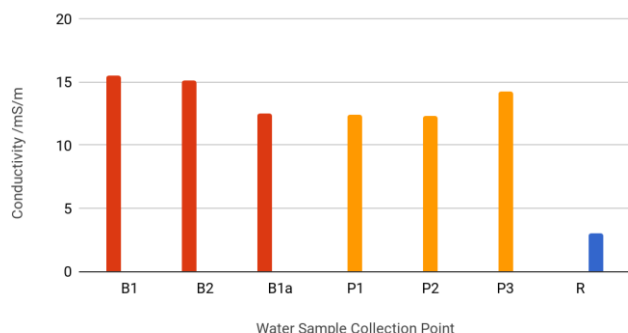
Figure 9: Graph of Conductivity 2018

Overall, a general decrease in conductivity of the water samples from the reed beds to polishing ponds and reservoir. The average conductivity of polishing ponds water samples was 12.99 mS/m, with a 15% reduction from 15.31 mS/m at the reed beds.

The bioremediation processes at Lorong Halus Wetland were also measured to be highly successful at removing phosphate and nitrate ions, along with a decrease in conductivity. As such, it is likely that the plants at the waterbody are adequate in removing pollutants to prevent the possibility of an algal bloom which would severely affect the ecosystem. The only possible anomaly was that of an increase in phosphate concentrations from the reed beds to polishing ponds, contrary to expectations and the 2017 pilot study; however, the above contradiction may have been caused by a variation in the testing equipment used, in which case it may be considered insignificant.

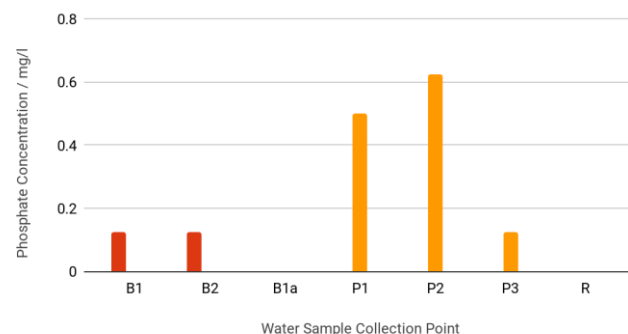
Figure 11: Graph of Phosphate Concentration 2018

However, readings for phosphate concentration deviated largely from expectations. The average phosphate concentration at the polishing ponds of 0.417 mg/l was higher than the 0.125 mg/l observed at the reed beds, while no phosphate was recorded in the reservoir water sample. It is worth noting that an Aquarium Pharmaceutical test kit was used for the 2018 phosphate tests in contrast to the sera test kits used for all the other tests, including the pilot phosphate concentration tests in 2017.

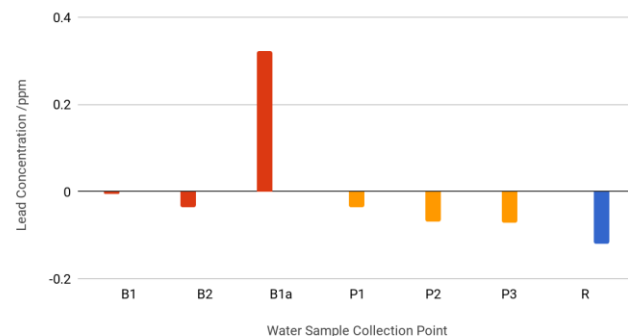
Figure 12: Graph of Lead Concentration 2018

Lead concentration decreased overall from 0.093 ppm at the reed beds to -0.059 ppm at the polishing ponds and -0.12 ppm reservoir, demonstrating how the higher lead concentrations exist at Lorong Halus Wetland as a previous landfill and that measures in place at Lorong Halus Wetland are indeed effective in preventing a leakage of lead into the reservoir.

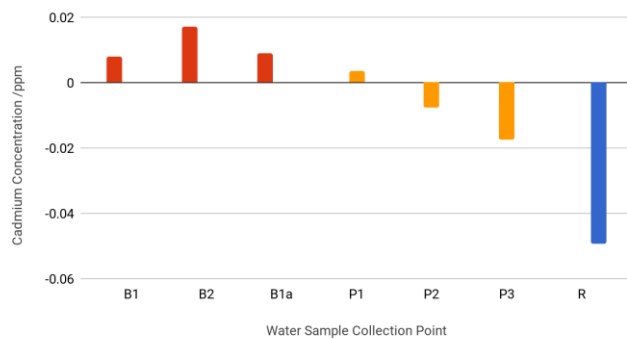
Figure 13: Graph of Cadmium Concentration 2018

Similarly, cadmium concentration decreased overall from an average of 0.0011 ppm at the reed beds to -0.0072 ppm at the polishing ponds and -0.0495 ppm at the reservoir, demonstrating how higher cadmium concentrations exist at Lorong Halus Wetland as a previous landfill and that measures in place at Lorong Halus Wetland are indeed effective in preventing a leakage of cadmium into the reservoir.

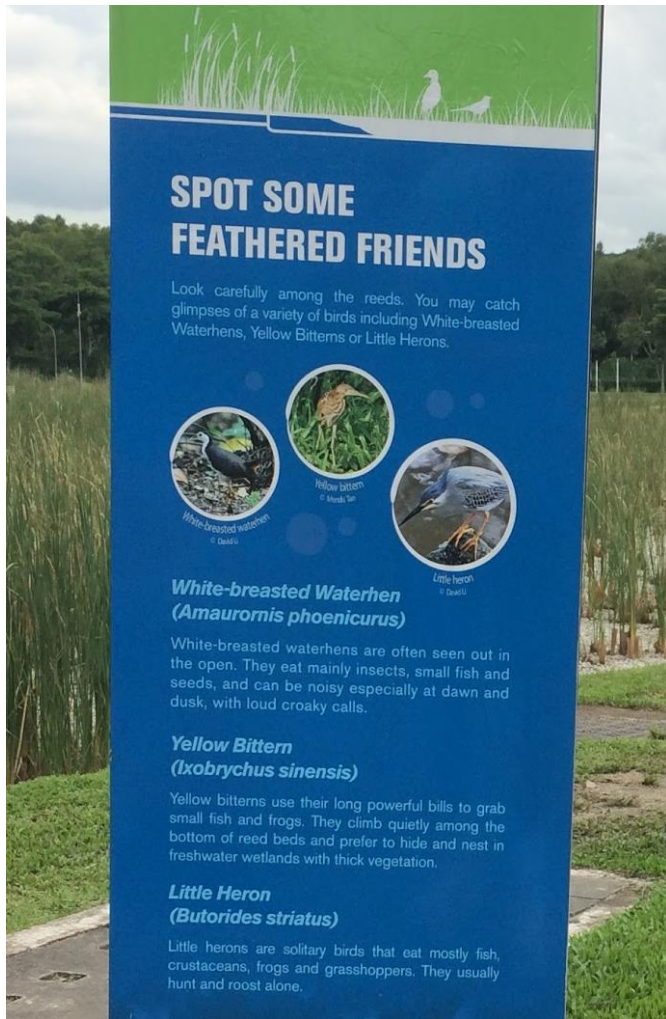
Figure 24: Newly-Installed Signboard at Lorong Halus reed beds

In contrast to the pilot project conducted in 2017, many signs in a state of disrepair have since been replaced and appear to be in good condition. Figure 24 shows a newly installed signboard. Regular cleaning of the signboards by contractors was also observed. This upkeep indicates that efforts to raise awareness of the wetland's purpose, water-related issues, and biodiversity in the wetland through signboards are valued by PUB.
