# The implications of land use on the state and health of a river system in a semi-arid region of South Africa

Phoebe Dredge<sup>1</sup>, Lara Marneweck<sup>2</sup>, Jordan Ralph<sup>1</sup> and Jarod Swart<sup>1</sup>

<sup>1</sup>Woodhill College, Pretoria, South Africa. <sup>2</sup>Hatfield Christian School, Pretoria, South Africa.  
catherine.m@curro.co.za

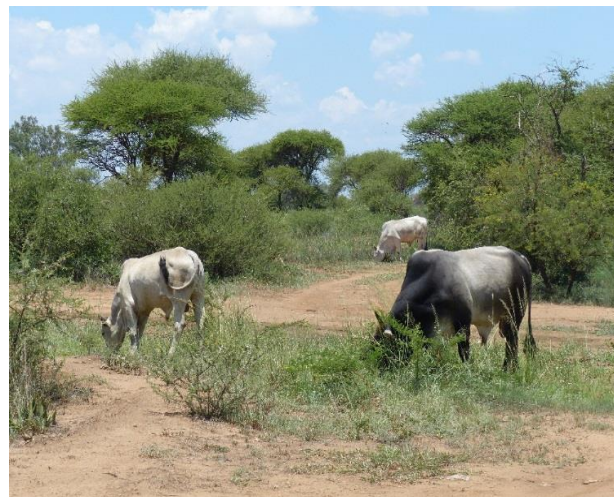
Figure 5: Livestock farming along the Pienaars River at Site 5

At Site 5 the Ecological State is *Good*. The site is away from urban areas and is surrounded mostly by natural vegetation and the riparian area is mostly natural. The main landuse upstream of this site is agriculture. Even although the site is used by livestock for drinking and grazing (see Figure 5), the river banks were not eroded at the site and this contributes to the *Good* Ecological State score. The water quality based on macroinvertebrate presence was *Very Poor*. This could be because of the poorer general water quality which included high levels of nitrate and orthophosphates compared to all the other sites upstream. The increase of these two levels could be due to the increase in smallholdings and agriculture along the river together with the influence of water that is released from the sewage works upstream. Both agriculture and sewage water would add to nitrate and orthophosphate levels.

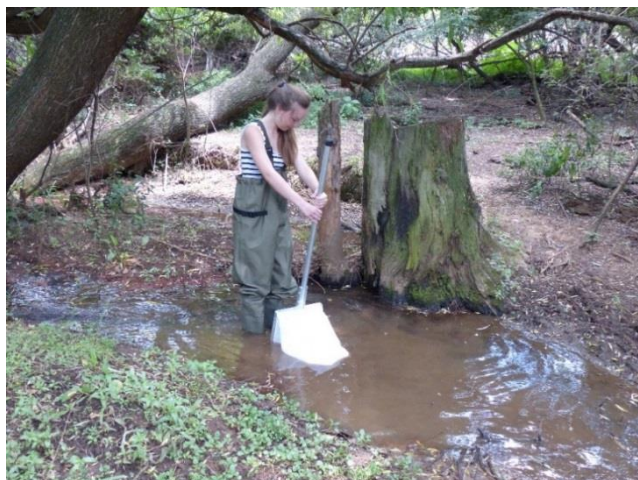
The main landuses are *urban, residential*. The headwaters are within the Moreleta Kloof Nature Reserve (Figure 8) which is managed by the Department of Environmental Management of the local municipality.

Figure 8: Sampling in the Moreleta River in Moreleta Kloof Nature Reserve.

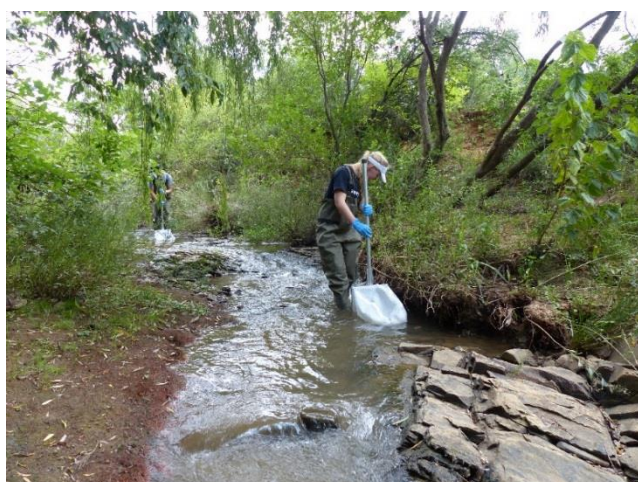
The main landuses are *urban, residential*. The water flows through wetlands before entering the Faerie Glen Nature Reserve (Figure 9), also managed by the municipality.

Figure 9: Sampling in the Moreleta River in the Faerie Glen Nature Reserve.

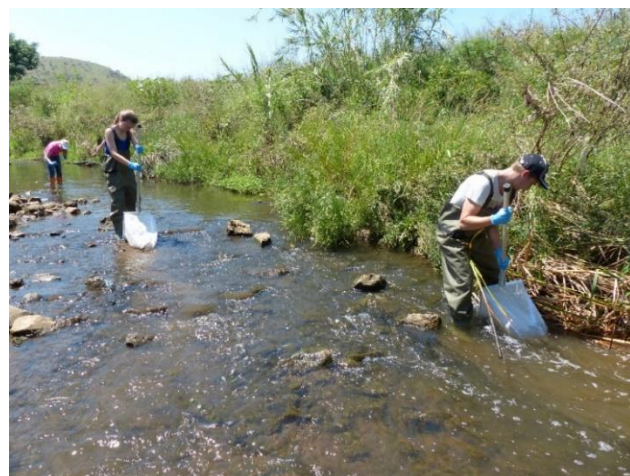
Figure 10: Sampling in the Moreleta River downstream of the industrial area. Note the open water and overhanging vegetation biotypes being sampled.

*Urban and industrial*. The water flows through more residential areas and then an industrial area and disturbed areas before reaching the sampling site. The site is within a camping resort and is very disturbed (Figure 10).

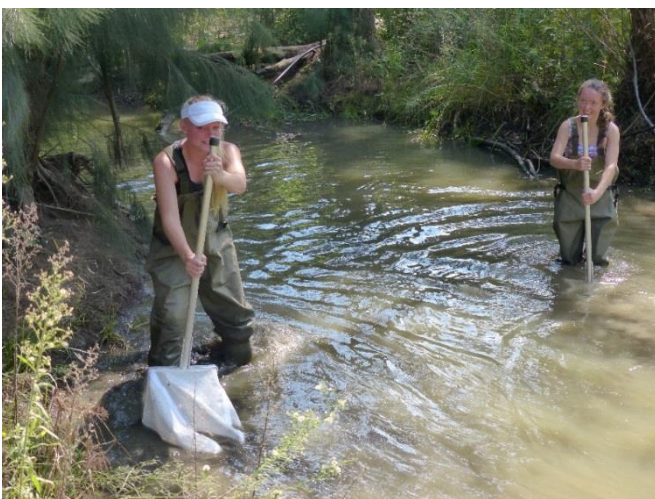
On the outskirts of the city. The water flows through small holdings of cultivated land and natural and exotic vegetation (Figure 12).

Figure 12: Sampling in the Pienaars River

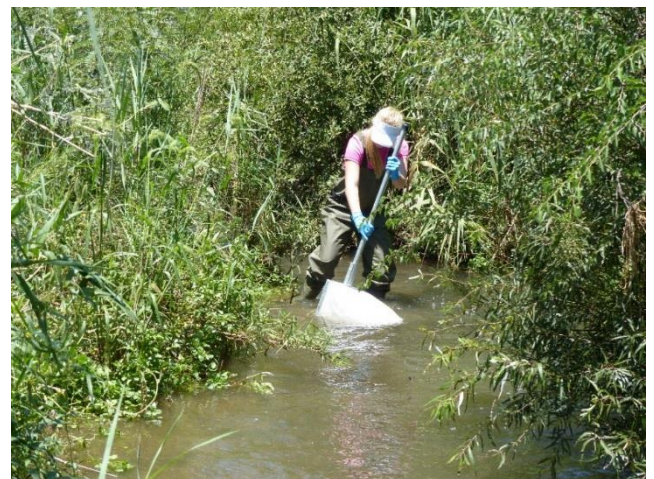
This site (Figure 14) is located downstream of where the Moreleta River and the Pienaars River join. The water flows through smallholdings (Moreleta River), natural vegetation (Pienaars River) and then enters the large, Roodeplaat Dam. After the dam, there is a sewage works adjacent to the river. The site occurs within communal land where there is agriculture and livestock farming.

Figure 14: Sampling on the Pienaars River downstream of the Roodeplaat Dam and sewage works.

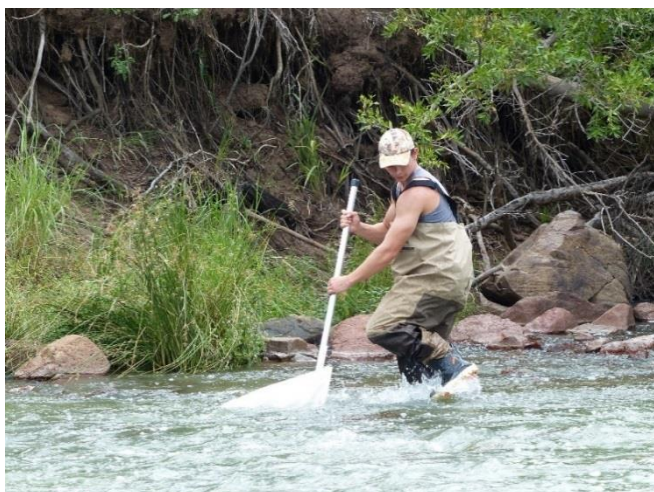
This site is located within the Borakalalo National Park (Figure 16) just after the river flows through the Klipvoor Dam. Before the dam, the water flows through agricultural land after extensive floodplain wetlands.

Figure 16: Sampling the Moretele River in the Borakalalo National Park.
