Varginha urban springs, state of preservation, and perspectives for reality changing

Gabriel Araújo¹, Matheus Silva¹, Rebecca Beutler¹, Cristina Vianna², Wagner Silva²
Students¹ and teachers² from Centro Federal de Educação Tecnológica de Minas Gerais Unidade
Varginha, Minas Gerais, Brazil.

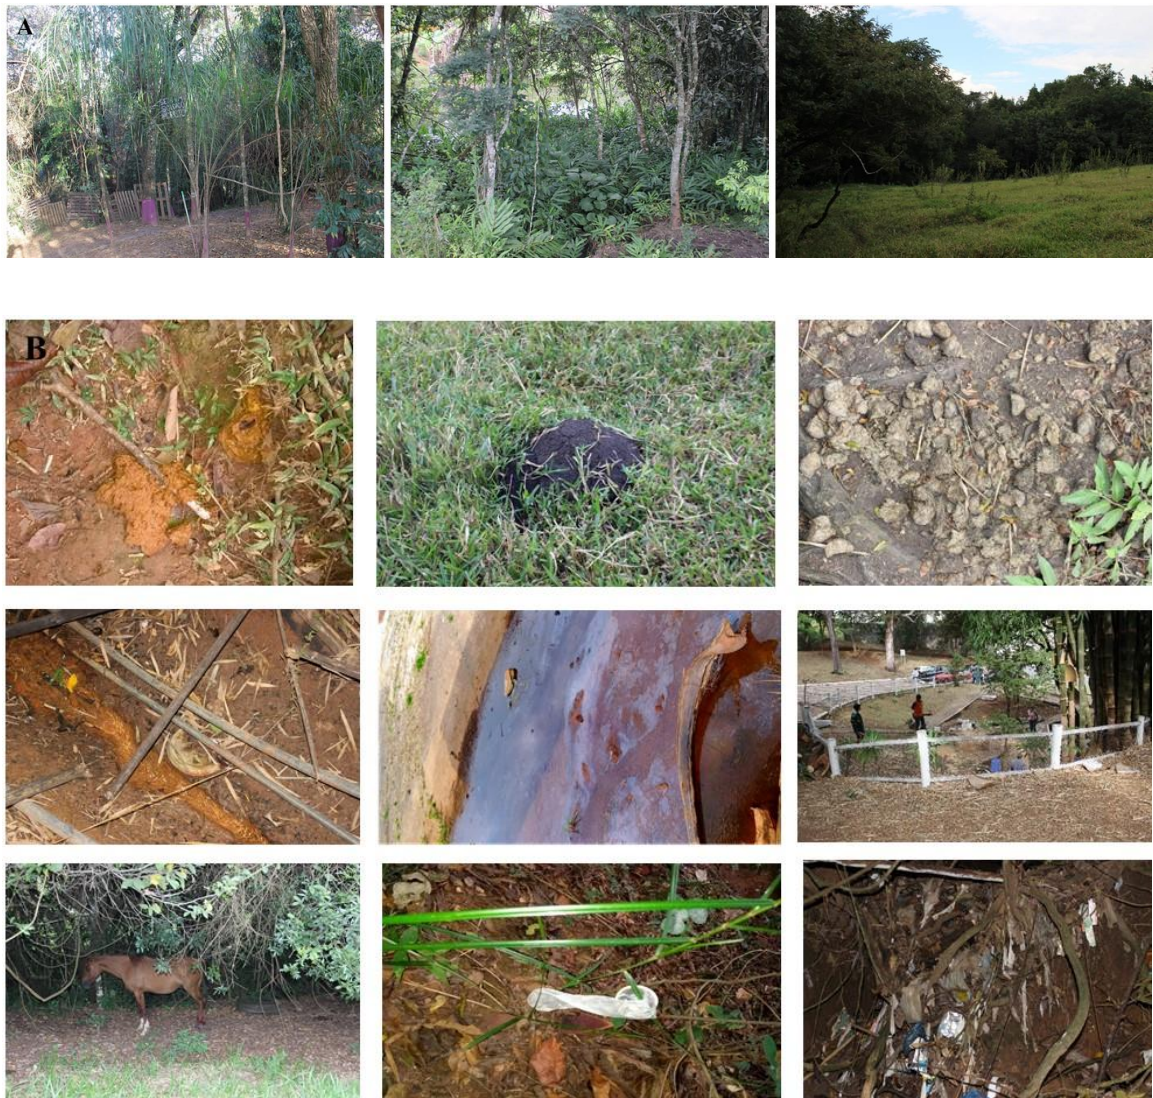
Figure 1: Photo-documentation of positive (A) and negative (B) aspects identified around the springs. A: Positive aspect – presence of riparian forest around some springs. B: negative aspects: presence of human and animal feces, presence of oils and absence of riparian vegetation, presence of animals and garbage

The study mapped 21 urban springs in the city of Varginha, Minas Gerais state. During the field visits, springs were photo-documented. Figure 1 shows some important aspects observed, negative and positive. However, it does not show the identification of each of the springs, as the authorization terms for the use of images were not signed by the owners of the places where
